# FLYING LESSONS for September 24, 2020

### **Plans, and Patience**

#### *From the NTSB:*

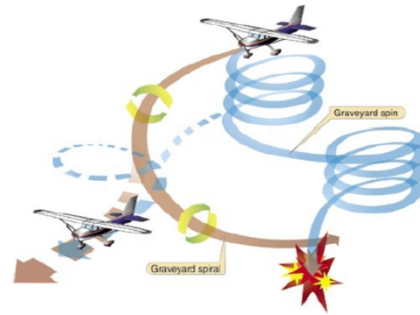
**As the airplane's nose** begins to point downward toward the earth the aircraft gains airspeed. Since a properly trimmed airplane will attempt to maintain a constant airspeed/AoA, it will now pitch “up”—relative to airplane, **not** the horizon. This “up” is pointed toward the center of the spiral. Pitching toward the center merely creates a steeper the bank angle, which reduces vertical lift more, which causes the nose to drop further, which causes even more speed, which makes the airplane pitch “up” even more...and so forth. This we sometimes call a “graveyard spiral.”

**All it takes** for an airplane to enter a graveyard spiral is for a pilot to become disoriented and to let the wings bank more than about 30 to 40 degrees. Enter IMC without the skills to fly by reference to instruments, with those skills but with inoperative instruments or contradictory instrument indications, and/or to be impaired by illness, medication, or fatigue, and enter a steep turn...and you'll probably slide into a graveyard spiral.
